Thruster Clearance

Highland Duke – Gt. Yarmouth, Norfolk

Date:
November 2015

Project Number:
115034

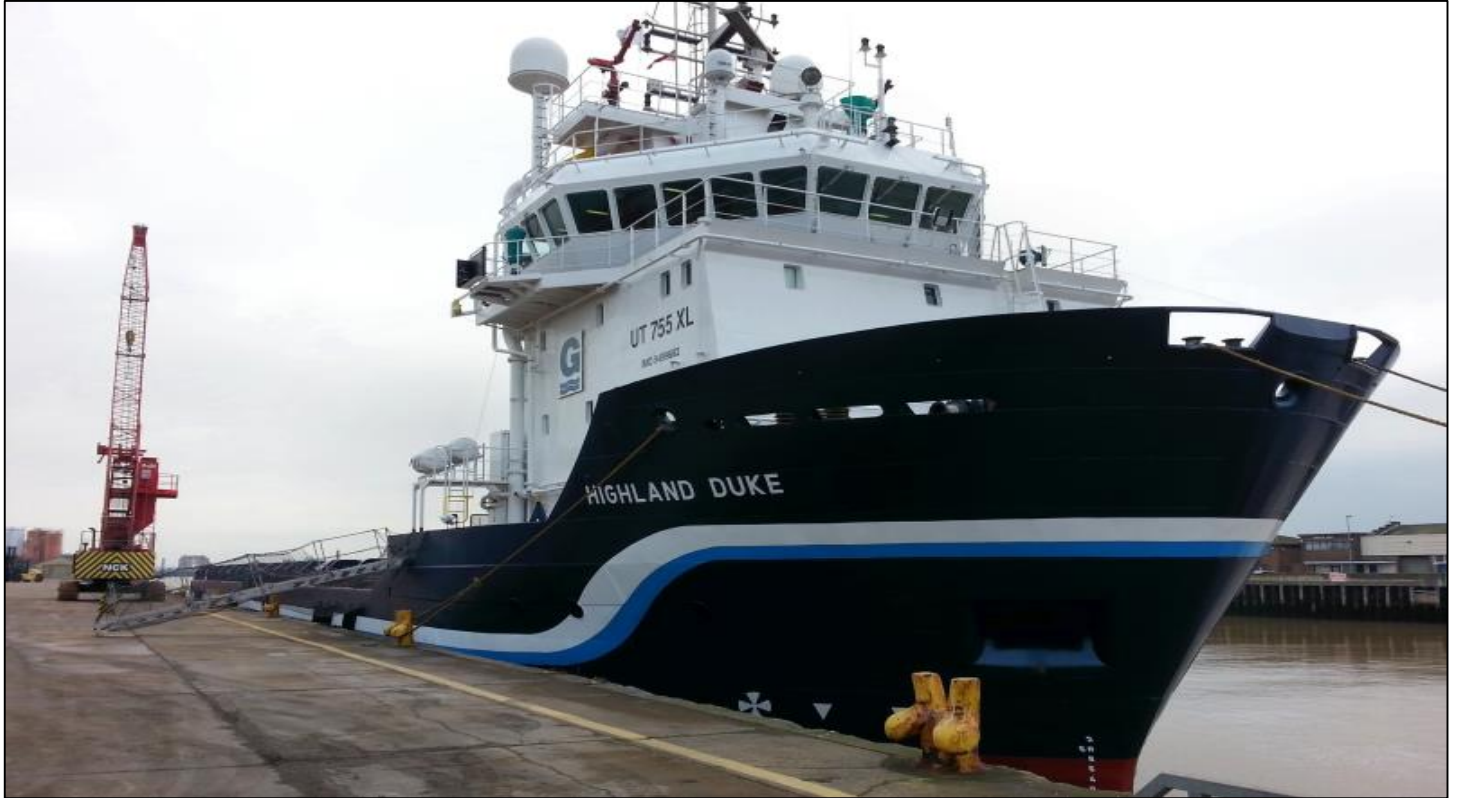
Within several hours of the vessel mooring within the port of Gt. Yarmouth, Red7 diving team were onsite setup, undertaking inductions and witnessing vessel isolations. Despite poor visibility and restricted access Red7 divers conducted and completed a survey of both of the vessels forward bow thrusters.

Although Red7 divers identified ways to remove protection grills allowing greater access into the thruster tunnel, it was deemed unnecessary. Paint damage and scarring was observed on the outside plating of the furthest forward thrusters' tunnel, however no debris was located within, and thruster blades were found to be without defect and moved freely.
